**UNIVERSITY GARDENS RESIDENTIAL DEVELOPMENT
WASTEWATER AND STORMWATER COLLECTION SYSTEMS**

Reconnaissance Inspection: Puerto Rico Aqueduct and Sewer Authority (PRASA) Puerto
Nuevo Regional Wastewater Treatment Plant (RWWTP) NPDES
Permit (PR0021555)

Autonomous Municipality of San Juan (MSJ) Municipal Separate
Storm Sewer System (MS4)
National Pollutant Discharge Elimination System (NPDES) Permit
(PRR040036)

Inspection Date: May 28, 2015

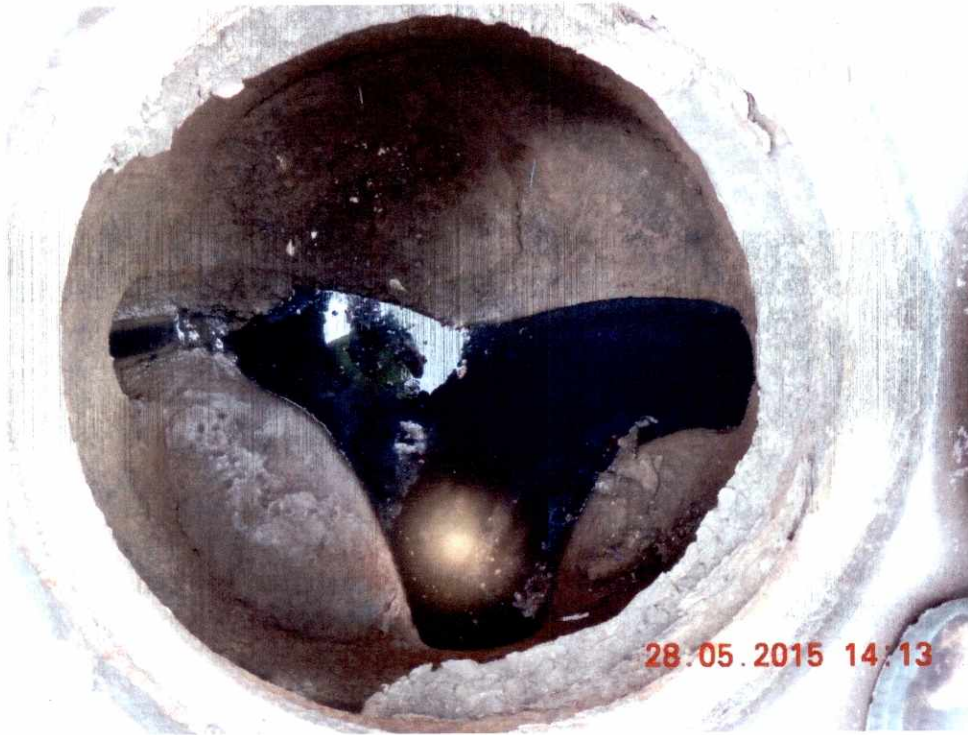
DSCN2152 – View of a wastewater manhole located in Sorbona and Princeton Streets intersection.

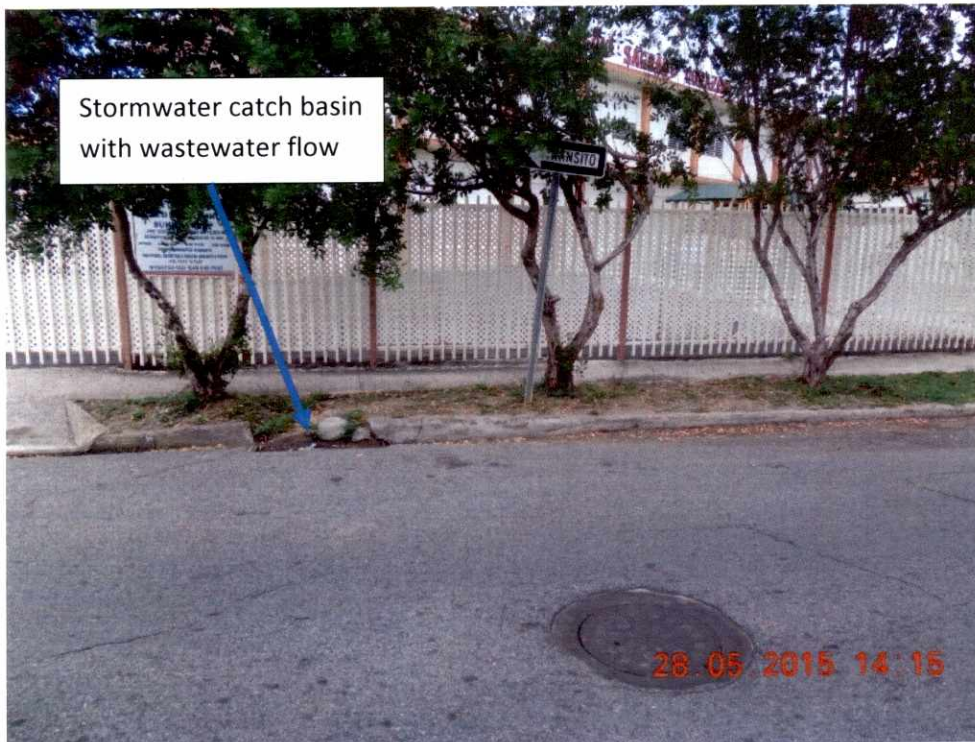
1. Dry-weather flow was observed in a stormwater catch basin located at Interamericana and Princeton Streets intersection (in front of “Colegio Sagrado Corazón” Coordinates: Lat. 18° 24’ 10.24” N – Long. 66° 3’ 45.00” W). The flow was observed going in direction of Princeton and Sorbona Streets intersection. Wastewater characteristics (i.e. color, odor, and algae formation) were observed.

A grab sample was taken; using ammonia test strips the ammonia level was approximately 6 mg/l. Fluorescent green dye was poured into the catch basin to determine its flow direction at 2:36 PM.

DSCN2153 – View of the Interamericana and Princeton Streets intersection. A stormwater catch basin located in the intersection and in front of the Sagrado Corazón School was found with dry-weather flow with wastewater characteristics.

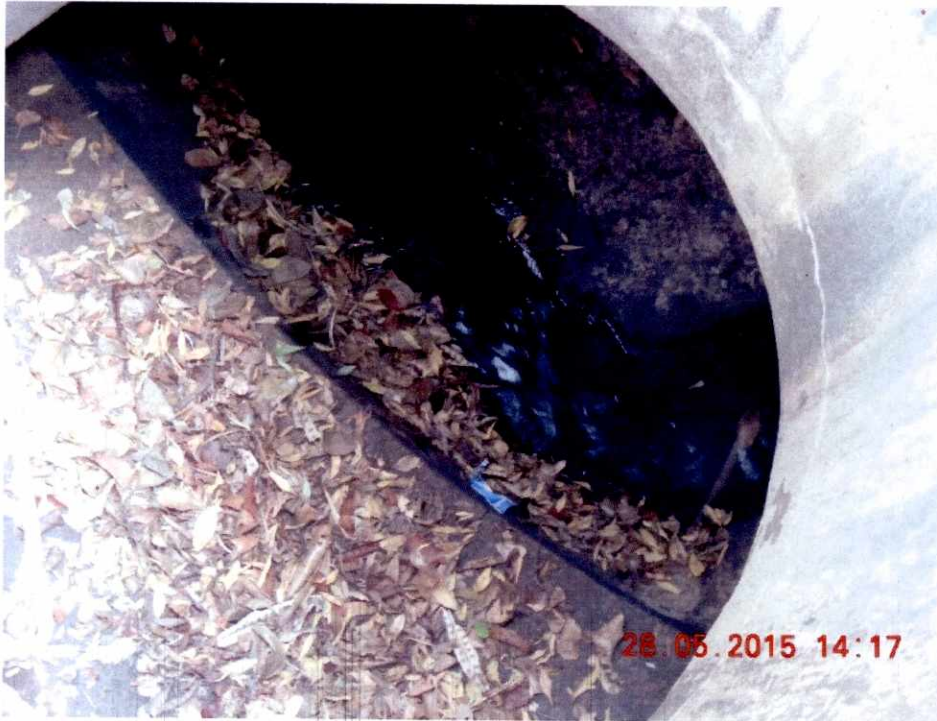
DSCN2154 – View of the bottom of a stormwater catch basin located at Interamericana and Princeton Streets intersection. The catch basin was found with dry-weather flow with wastewater characteristics.

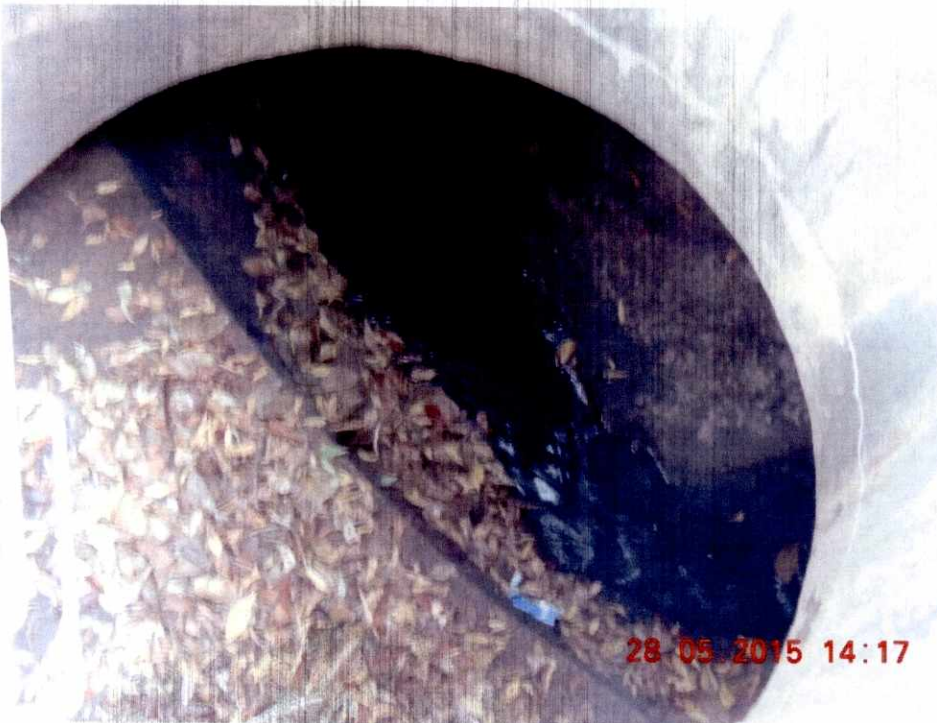
DSCN2155 – Additional view of the bottom of the stormwater catch basin located at Interamericana and Princeton Streets intersection. The catch basin was found with dry-weather flow with wastewater characteristics. A grab sample was taken and using ammonia test strips the ammonia level was approximately 6 mg/l.

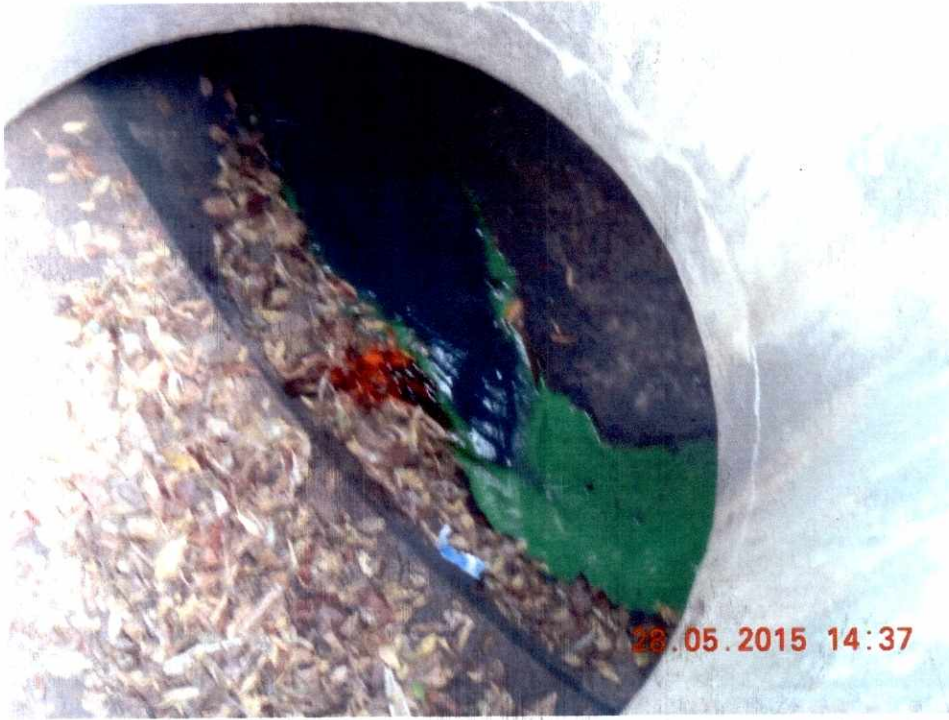
DSCN2156 – Additional view of the bottom of a stormwater catch basin located at Interamericana and Princeton Streets intersection. The catch basin was found with dry-weather flow with wastewater characteristics. Fluorescent green dye was poured into the catch basin to determine its flow direction.

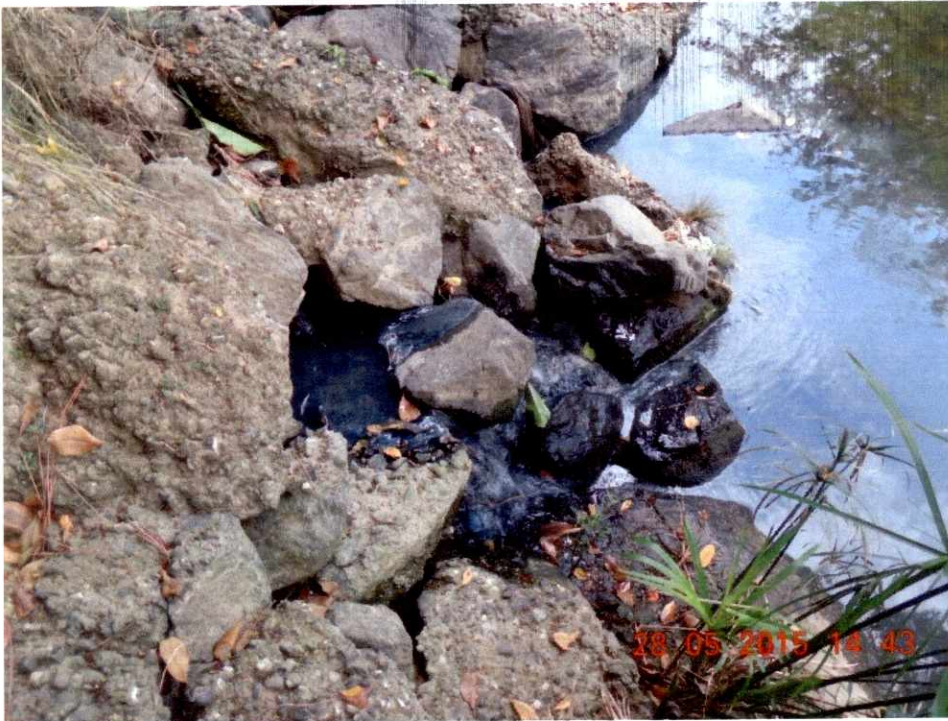
3. A wastewater discharge was found reaching the Río Piedras River from an approximately 48 inches diameter concrete pipe located southwest of Princeton and Sorbona Streets intersection (Coordinates: Lat. 18° 24’ 9.01” N – Long. 66° 3’ 47.03” W). Strong wastewater odor, algae formation and grayish flow were noted.

DSCN2157 – A wastewater discharge was found reaching the Río Piedras River from an approximately 48 inches diameter concrete pipe located southwest of Princeton and Sorbona Streets intersection (Coordinates: Lat. 18° 24' 9.01" N – Long. 66° 3' 47.03" W). Strong wastewater odor, algae formation and grayish flow were noted.

MSJ and PRASA shall take the necessary actions to cease discharging wastewaters into Waters of the United States. The response to this report shall include all the details, evidence, and results of such actions.

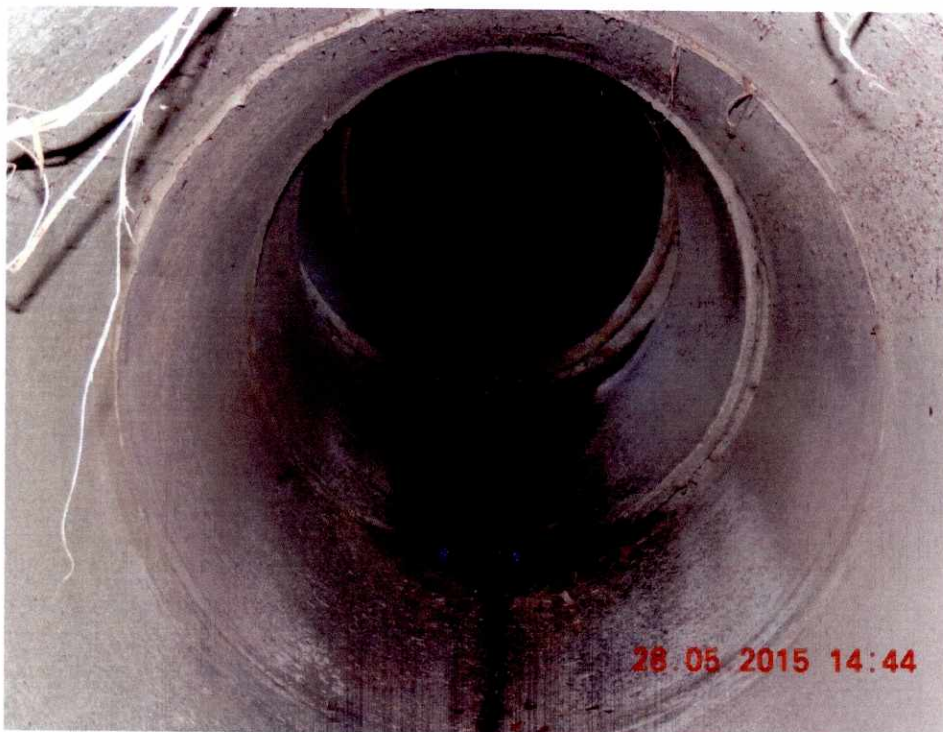
DSCN2158 – Additional view of the wastewater discharge that was found reaching the Río Piedras River from an approximately 48 inches diameter concrete pipe located southwest of Princeton and Sorbona Streets intersection. Strong wastewater odor, algae formation and grayish flow were noted. The flow is discharged thru a displaced section of the pipe.

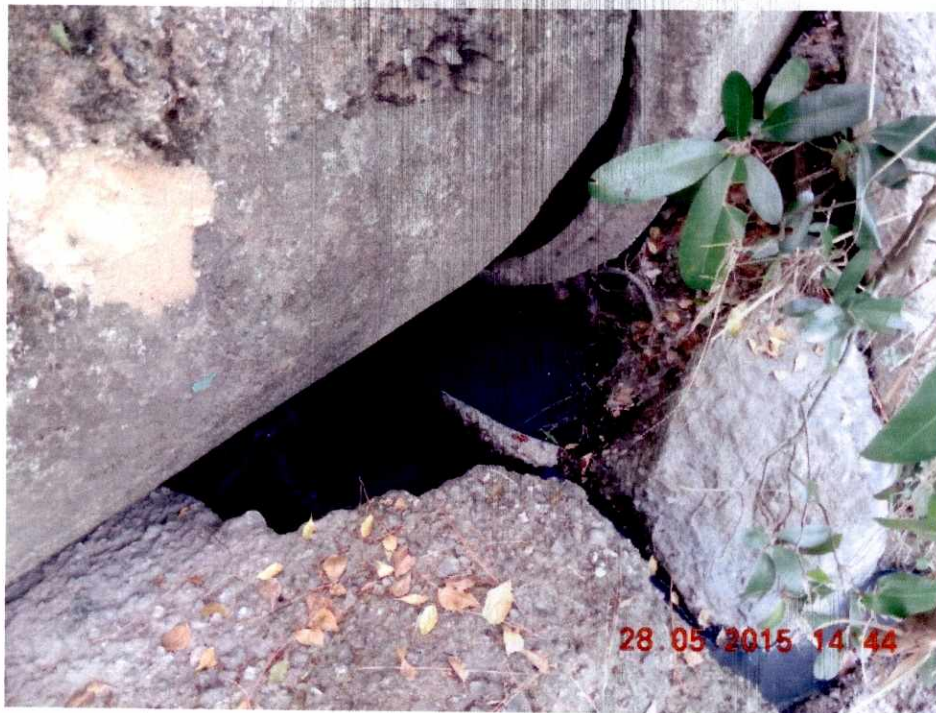
DSCN2159 – Additional view of the wastewater discharge that was found reaching the Río Piedras River from an approximately 48 inches diameter concrete pipe located southwest of Princeton and Sorbona Streets intersection. Strong wastewater odor, algae formation and grayish flow were noted. The flow is discharged thru a displaced section of the pipe.

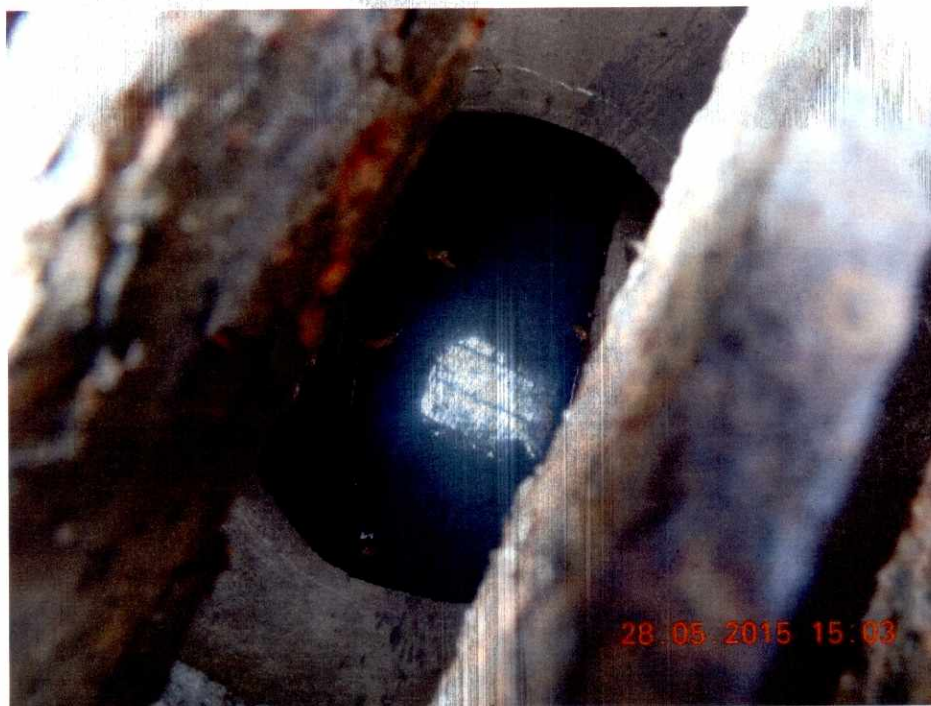
2. A dry-weather flow with wastewater characteristics (e.g. color, odor, and algae formation) was observed in a stormwater catch basin located in Sorbona and Princeton Streets intersection (Coordinates: Lat. 18° 24’ 8.97” N – Long. 66° 3’ 46.20” W). The fluorescent green dye was observed in the catch basin around 3:07 PM. The flow was observed going in direction of the Río Piedras River.

DSCN2160 – View of the bottom of a stormwater catch basin located in Princeton and Sorbona Streets intersection. A dry-weather flow with wastewater characteristics (e.g. color, odor, and algae formation) was observed

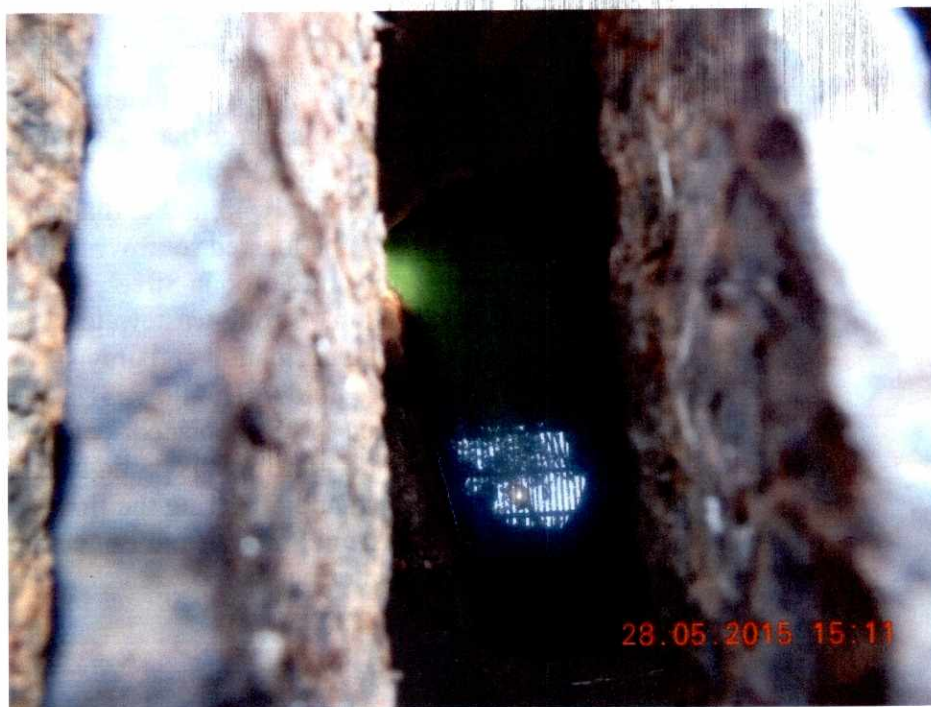
DSCN2161 – View of the bottom of a stormwater catch basin located in Princeton and Sorbona Streets intersection. A dry-weather flow with wastewater characteristics (e.g. color, odor, and algae formation) was observed. The fluorescent green dye poured in the Interamericana and Princeton Street intersection stormwater catch basin appeared at the catch basin. The catch basin flows in direction of the Río Piedras River thru the 48 inches pipe described in photos DSCN2157 thru DSCN2159.

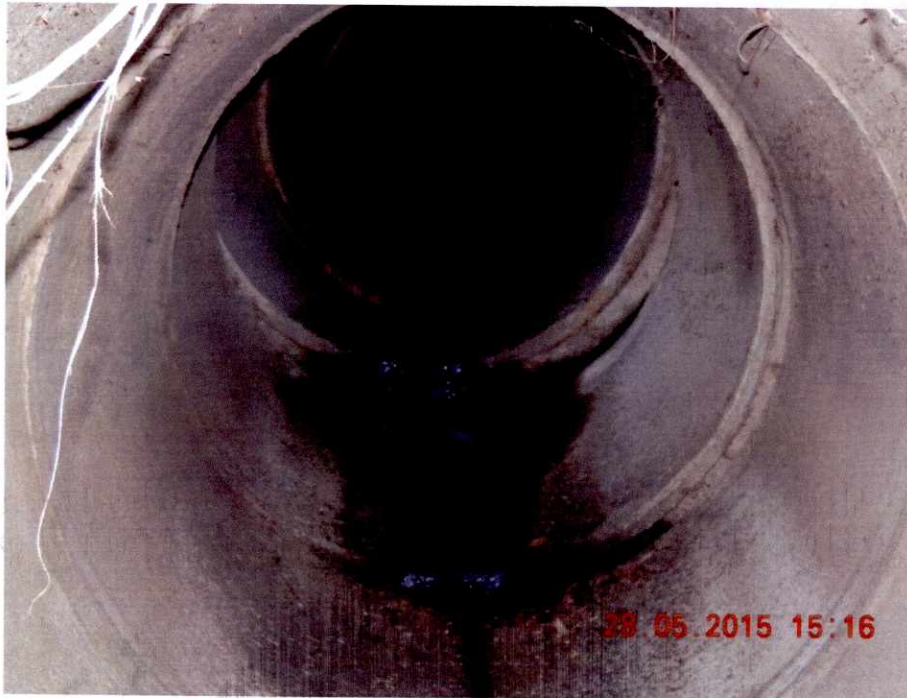
DSCN2162 – Additional view of the wastewater discharge that was found reaching the Río Piedras River from an approximately 48 inches diameter concrete pipe located southwest of Princeton and Sorbona Streets intersection. Strong wastewater odor, algae formation and grayish flow were noted. The flow is discharged thru a displaced section of the pipe.

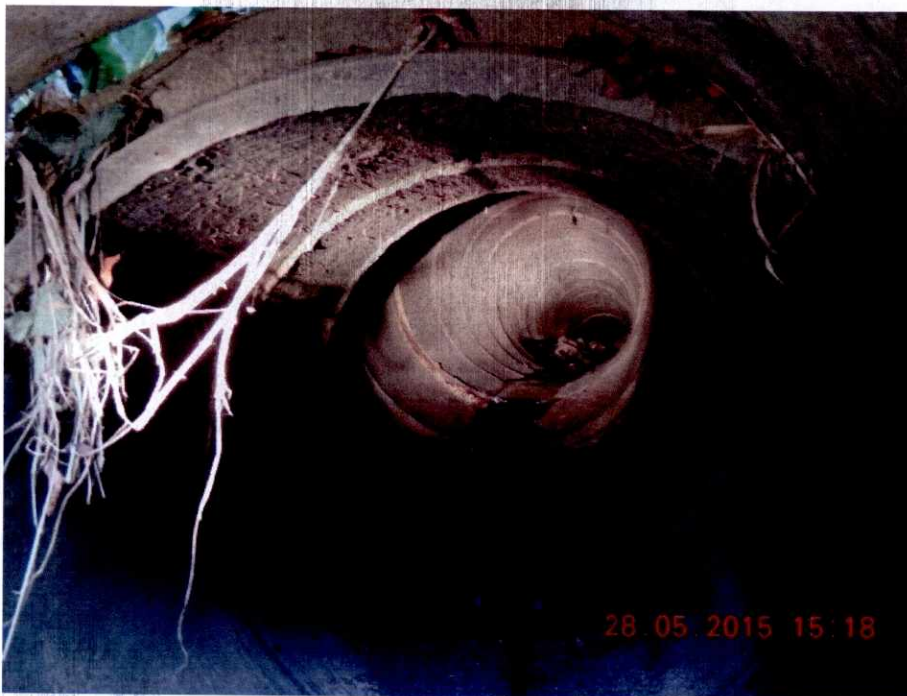
Although the Inspectors were not able to document the fluorescent green dye reaching the Río Piedras River, the stormwater catch basin located at Princeton and Sorbona Street (see item 3) was illuminated using a flash light and the light was seen thru the discharge pipe. As described in paragraph 2 the dye reached the Princeton and Sorbona catch basin meaning that the sewage discharge does ultimately discharge from this outfall. The pipe is partially obstructed and hindering the flow coming from Sorbona and Princeton Streets intersection.

DSCN2163 – Additional view of the wastewater discharge that was found reaching the Río Piedras River from an approximately 48 inches diameter concrete pipe located southwest of Princeton and Sorbona Streets intersection. Strong wastewater odor, algae formation and grayish flow were noted. The flow is discharged thru a displaced section of the pipe. The pipe is partially obstructed and hindering the flow coming from Sorbona and Princeton Streets intersection.

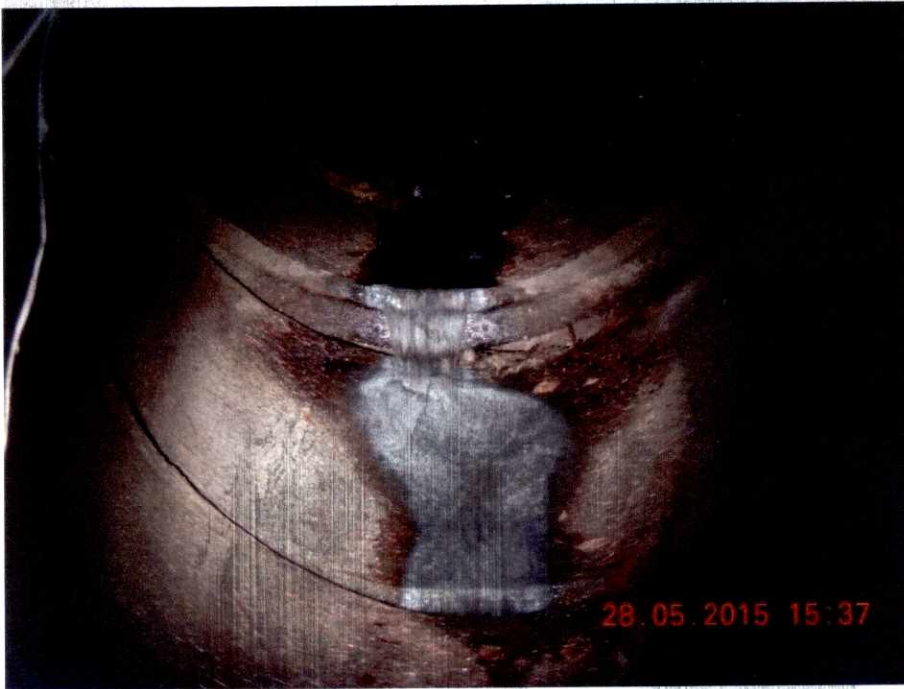
DSCN2164 – Additional view of the wastewater discharge that was found reaching the Río Piedras River from an approximately 48 inches diameter concrete pipe located southwest of Princeton and Sorbona Streets intersection. Strong wastewater odor, algae formation and grayish flow were noted. The flow is discharged thru a displaced section of the pipe.

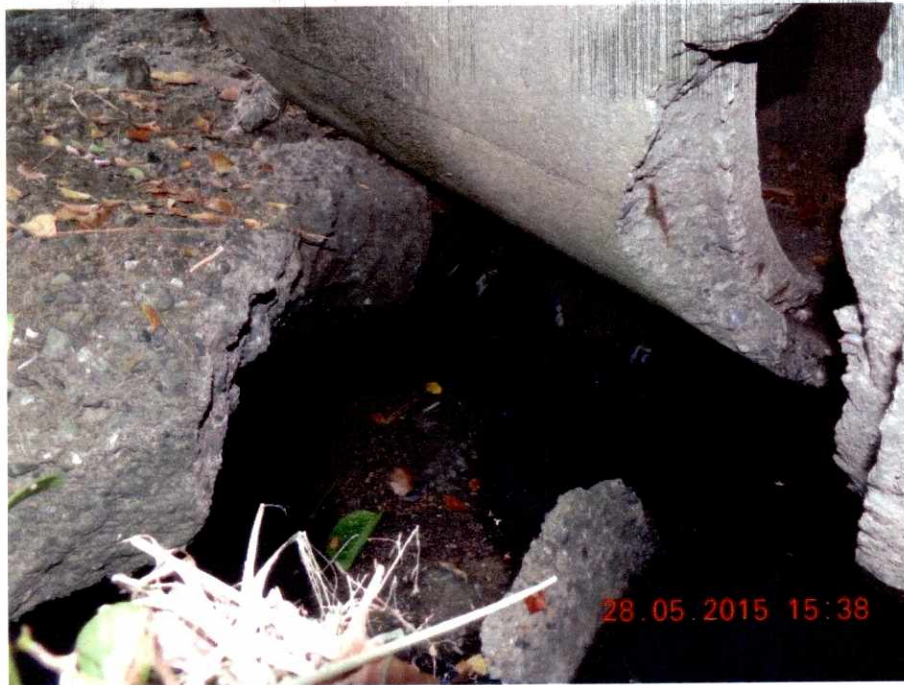
DSCN2165 – Additional view of the wastewater discharge that was found reaching the Río Piedras River from an approximately 48 inches diameter concrete pipe located southwest of Princeton and Sorbona Streets intersection. Strong wastewater odor, algae formation and grayish flow were noted. The flow is discharged thru a displaced section of the pipe.

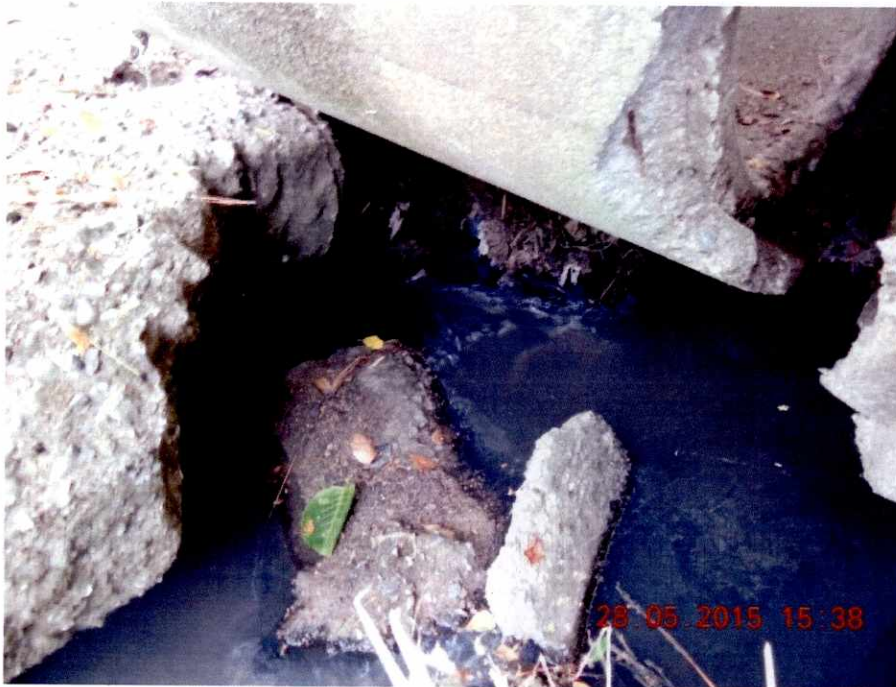
DSCN2166 – Additional view of the wastewater discharge that was found reaching the Río Piedras River from an approximately 48 inches diameter concrete pipe located southwest of Princeton and Sorbona Streets intersection. Strong wastewater odor, algae formation and grayish flow were noted. The flow is discharged thru a displaced section of the pipe.

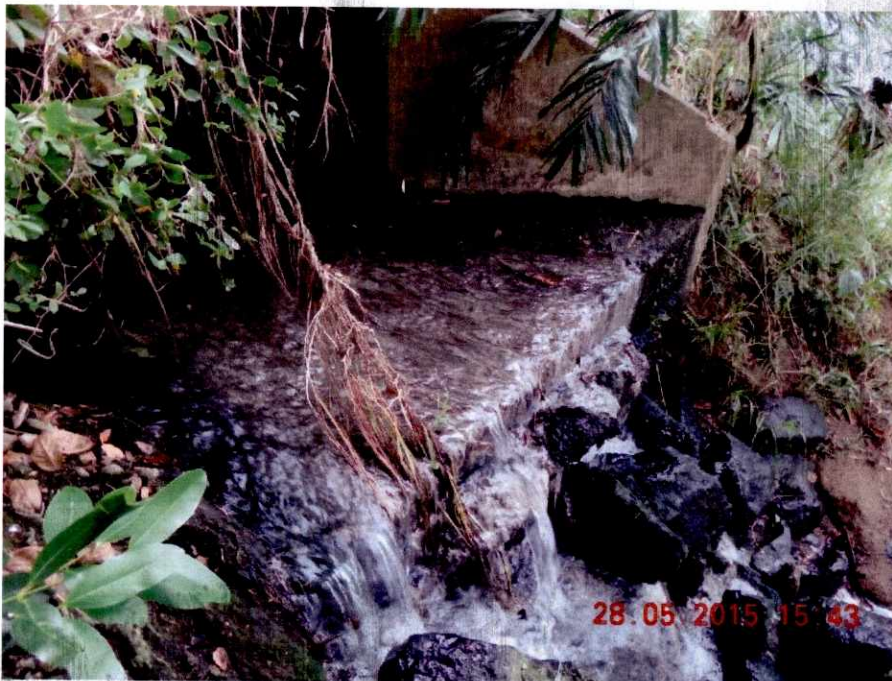
4. Significant amount of dry-weather flow with wastewater characteristics (e.g. color, algae formation and foam formation) was observed flowing from a rectangular outfall located south of Princeton and Sorbona Streets intersection and discharging into the Río Piedras River (Coordinates: Lat. 18° 24’ 8.54” N – Long. 66° 3’ 46.28” W).

A test for surfactants was performed; the surfactants levels were greater than 3 ppm. A grab sample was taken and using ammonia test strips the ammonia level was approximately 6 mg/l.

DSCN2167 – View of a rectangular outfall located south of Princeton and Sorbona Streets intersection (Coordinates: Lat. 18° 24' 8.54" N – Long. 66° 3' 46.28" W). Significant amount of dry-weather flow with wastewater characteristics (e.g. color, algae formation and foam formation) was observed. A test for surfactants was performed; the surfactants levels were 3 ppm. A grab sample was taken and using ammonia test strips the ammonia level was approximately 6 mg/l.

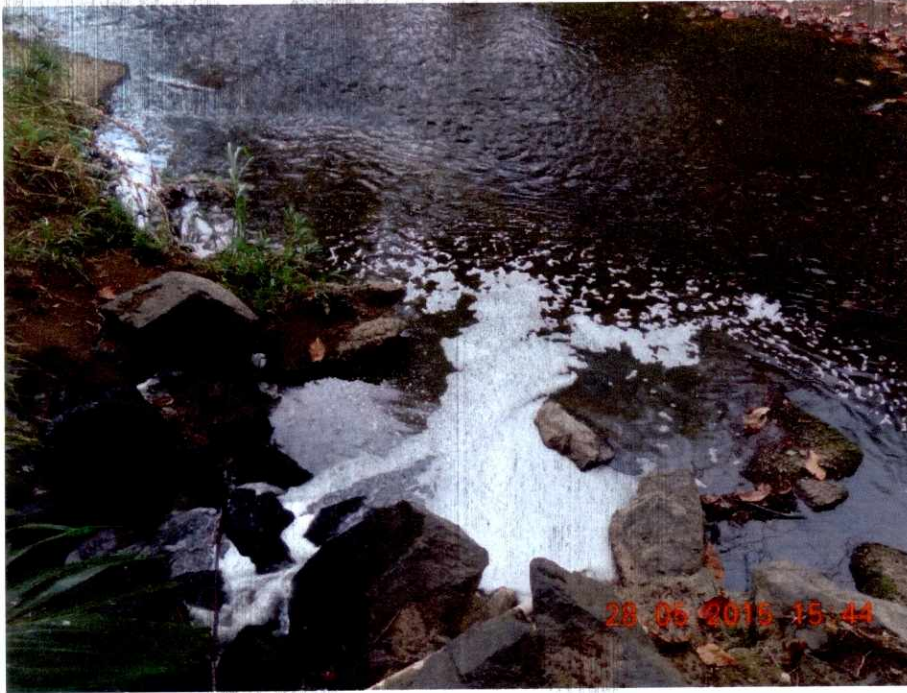
DSCN2168 – Partial view of the discharge from a rectangular outfall located south of Princeton and Sorbona Streets intersection. Significant amount of dry-weather flow with wastewater characteristics (e.g. color, algae formation and foam formation) was observed reaching the Río Piedras River. A test for surfactants was performed; the surfactants levels were 3 ppm. A grab sample was taken and using ammonia test strips the ammonia level was approximately 6 mg/l.

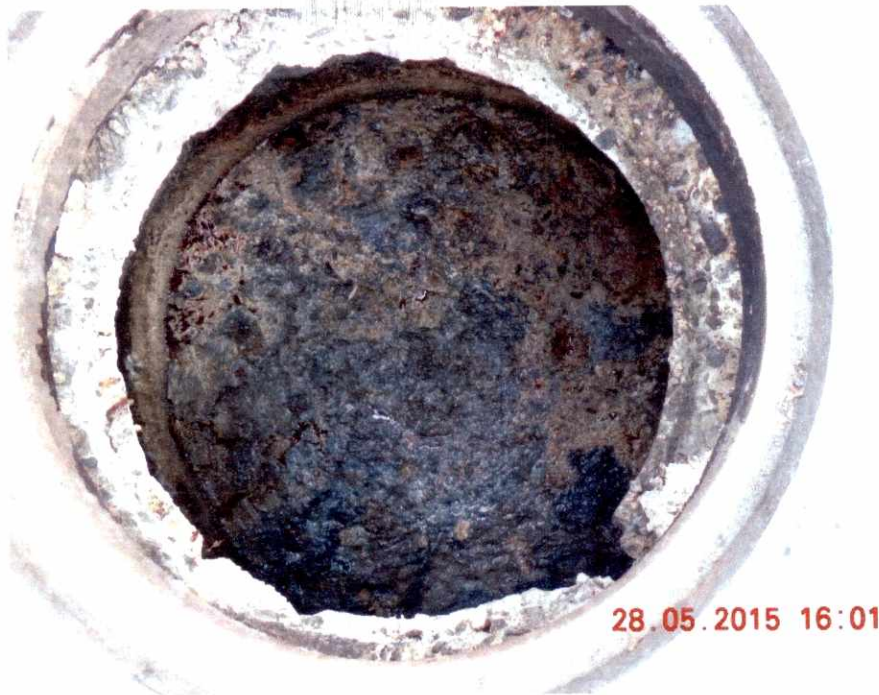
5. The wastewater manhole at Palma Real and Duke Street intersection was found full and with solids (i.e. grease) accumulation. The wastewater manhole is located at Coordinates: Lat. 18° 24' 14.86" N – Long. 66° 3' 36.16" W.

DSCN2169 – View of a wastewater manhole at Palma Real and Duke Streets intersection was found full and with solids (i.e. grease) accumulation.

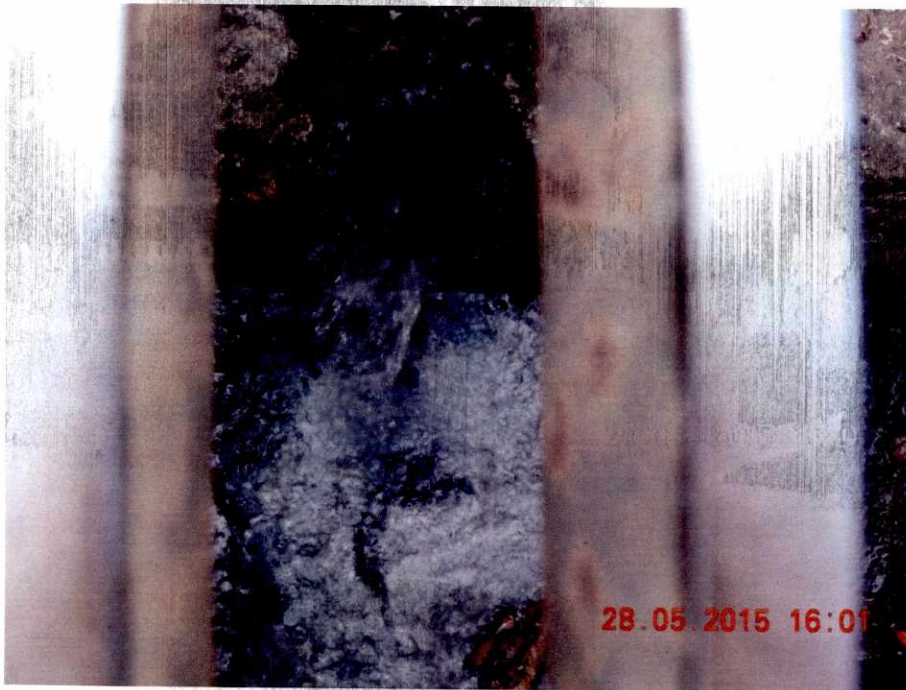
The stormwater trench inlet located in the same intersection (southwest of the wastewater manhole) was found with presence of dry-weather flow with wastewater characteristics (e.g. color, odor, and algae formation). The wastewater was observed flowing from the trench inlet inner wall and reaching a stormwater collection system that flows in direction of Interamericana Street.

DSCN2171 – Partial view of the inner part of a stormwater trench inlet located in Palma Real and Duke Streets intersection (southwest of the wastewater manhole) was found with presence of dry-weather flow with wastewater characteristics (e.g. color, odor, and algae formation). The wastewater was observed flowing from the trench inlet inner wall.

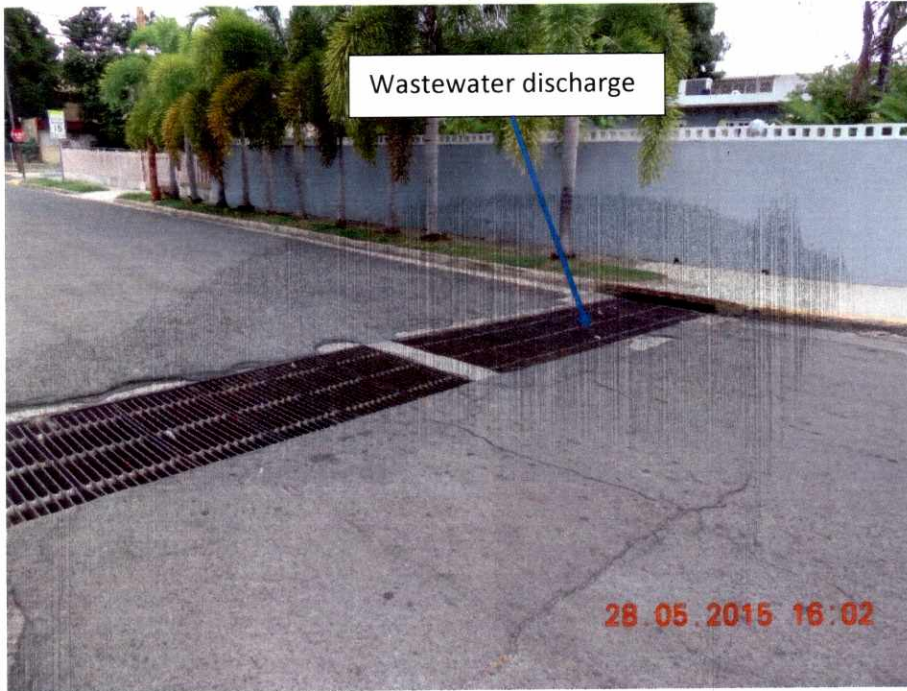
The intersection stormwater trench inlet is divided in two sections, one that flows into a concrete pipe similar to the one described in item 3, and other that flows thru a rectangular type of channel similar to the one described in item 4.

DSCN2172 – Partial view of Palma Real and Duke Streets intersection stormwater trench inlet. The intersection stormwater trench inlet is divided in two sections.

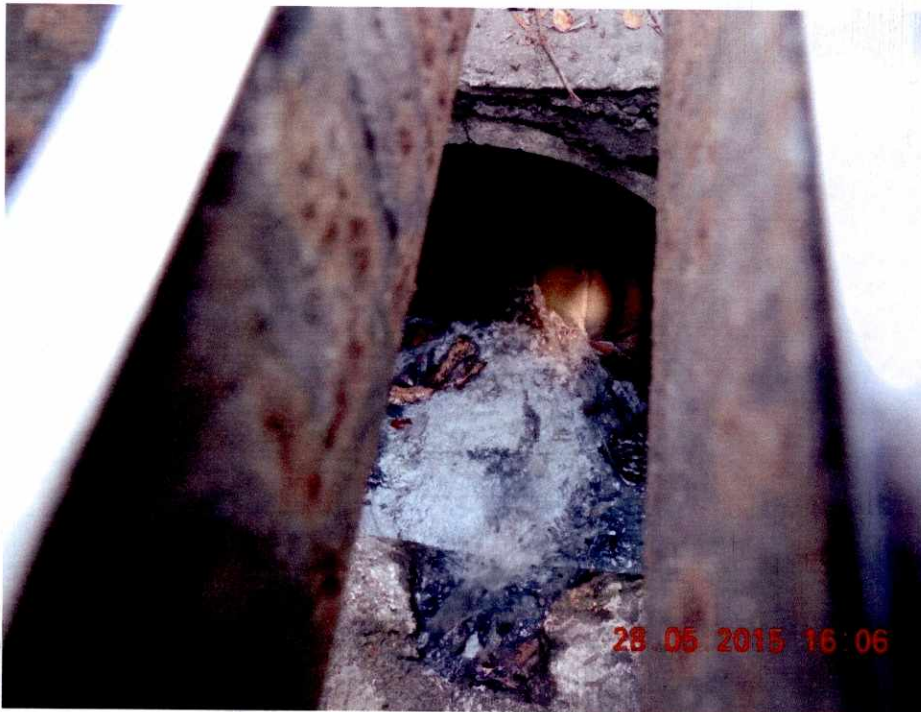
DSCN2174 – Additional view of the inner part of a stormwater trench inlet located in Palma Real and Duke Streets intersection (southwest of the wastewater manhole) was found with presence of dry-weather flow with wastewater characteristics (e.g. color, odor, and algae formation). The wastewater was observed flowing from the trench inlet inner wall.
